A Discussion on Personnel Exposure to Posttest Byproducts from a 50-cal. Light Gas Gun

Don Henderson

NASA Johnson Space Center White Sands Test Facility

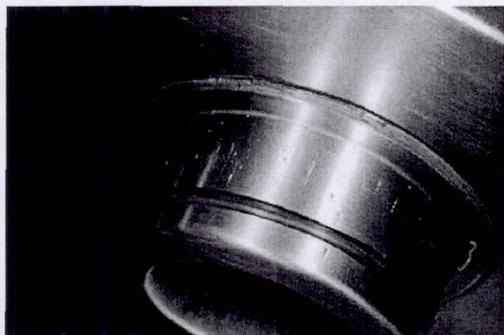
wstf0905E07780

be contributing to the release of post-shot gases. First, the pump tube end that mates with the breech was found to have small longitudinal gouges. These gouges prevented the O-ring from sealing the joint. Second, the purge lines were filled with soot from the shots. The lines remained connected during shots to pull vacuum, deliver hydrogen, and purge the pump tube. The pressure of the expanding gun powder gases was forcing debris into the $\frac{1}{4}$ -in. line, which reduced the flow to a crawl; but the pressure gauges used to set the purge pressure read correctly. Third, the 50-cal. gun was positioned on the west, or windward, side of the building, which is the direction of the prevailing winds in Las Cruces. This position was contributing to the entrainment of gases into the HVAC systems. (The 1-in. gun is on the leeward side of the building.) Fourth, the overpressure relief devices on the flight ranges emptied directly into the gun lab. When the pump tube gases leaked past the piston they soon entered the breathing-air zone. Corrective actions have improved but not completely alleviated these conditions.

Pump Tube End

5. Exhaust fans are used during testing to help evacuate gases.
6. Pump tube O-rings are inspected and usually replaced after each shot. It was found that in cleaning the mating sections of the pump tube, O-rings were scoured and, therefore, not providing a proper seal.

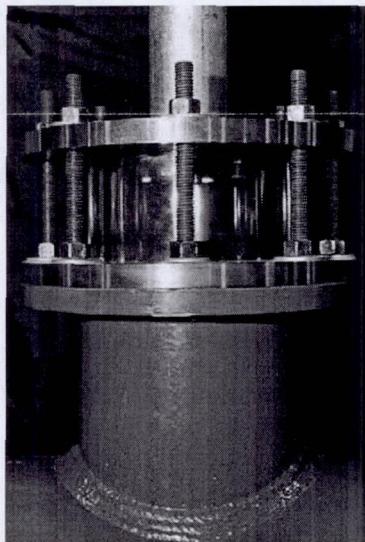
wstf0905E07782

Capture Vent2

3. Polycarbonate lift-off plates were installed on all indoor flight ranges and, when possible, opposite the GN₂ purge fill line. The exhaust is captured and vented outdoors above the roofline. The lift-off plates serve three purposes. First, there is a small risk of over-pressurizing flight ranges during the test process. The lift-off plate thusly serves as a captured relief valve for the flight range. Second, a GN₂ purge is required after each test to evacuate gases and particulate. The GN₂ purge flow is controlled to lift off the plate and provide a captured path for this purge. Since the plate can be viewed lifting, one can check the flow. Third, the polycarbonate is translucent, which provides a place to use photo diodes to capture muzzle exit times.

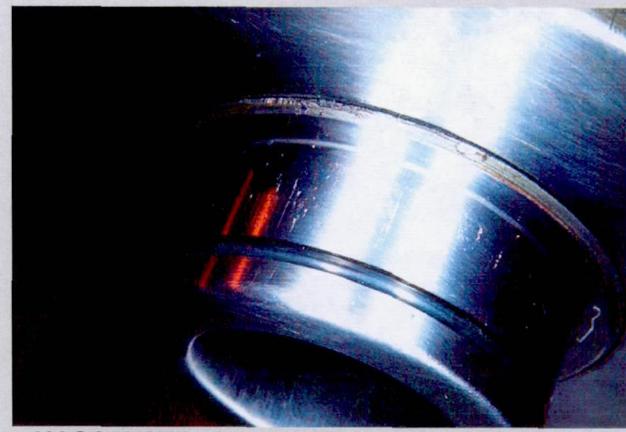
NASA WSTF photo WSTF0905E07780

Pump Tube End
